# Camber Aerial — Sample Inspection Report

**Sample report** from a real survey of a building owned by Camber Aerial's principal.

- **Property:** 2009 N Western Ave, Chicago, IL
- **Survey date:** May 1, 2022
- **Pilot:** Juan J. Lazo Jr., FAA Part 107 certified
- **What we flew:** Front, side and rear walls, plus the roof

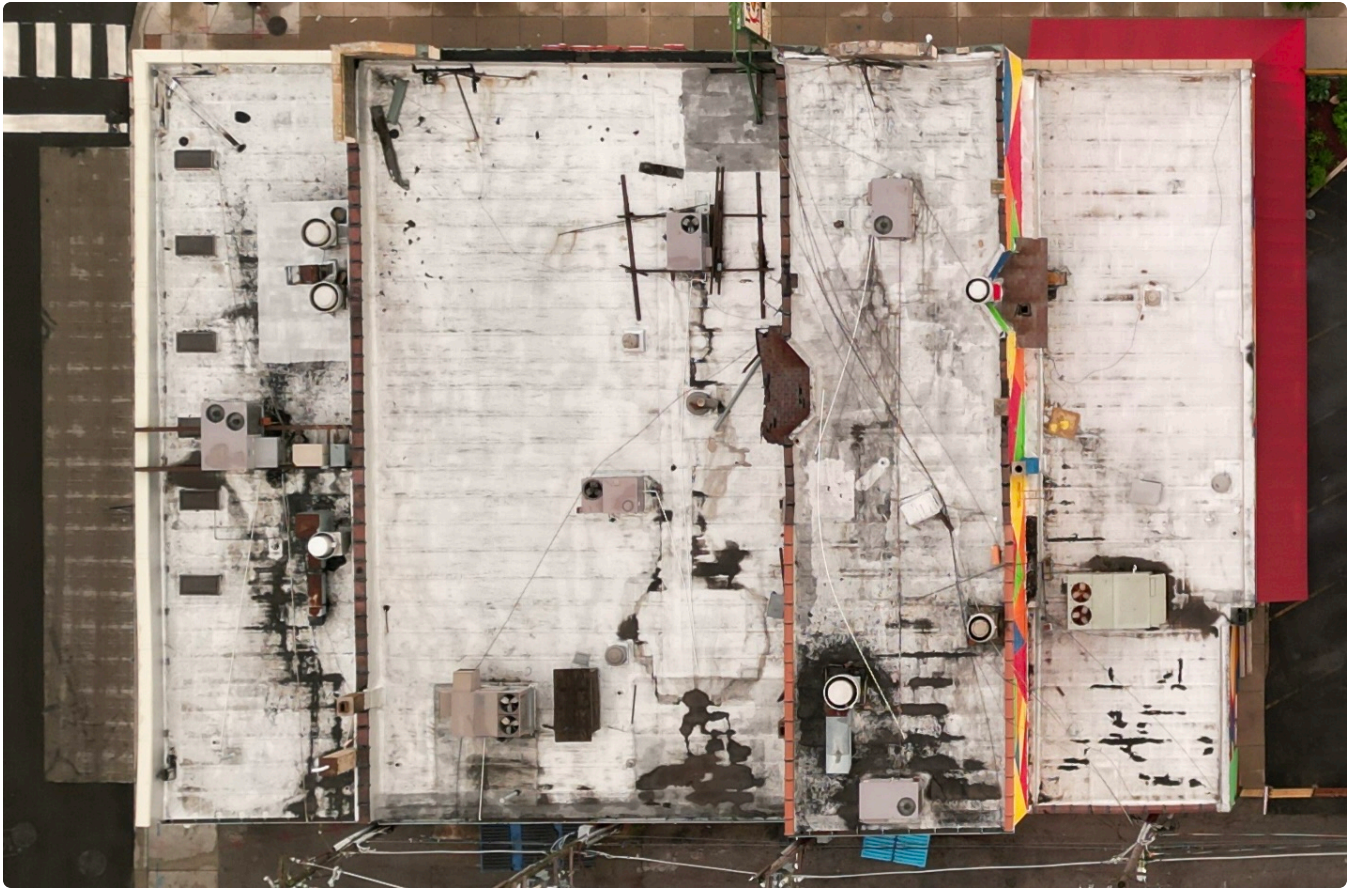
**No major damage worth repairing.** The roof shows normal wear for its age: dark staining where rainwater collects, a weathered coating, and leftover equipment frames and cables. None of it needs repair at this time.

| Area | What we checked | Condition | Photos |
|---|---|---|---|
| Roof | Surface, coating, drains, rooftop equipment | Minor wear only: staining from standing water, weathered coating, unused equipment frames and loose cables | P-1 |

*P-1: Overhead view of the roof, May 1, 2022. The dark patches are surface staining where rainwater collects, not holes or tears.*

1. No repairs needed at this time.
2. Check the stained low spots after a heavy rain. If water is still sitting after 48 hours, have a roofer look at drainage.
3. Consider removing the unused equipment frames and loose cables to cut down on future clutter and trip hazards.
4. Fly again in 12 to 24 months, using these photos as the baseline for comparison.
